DEPARTMENT OF TRANSPORTATION

Contract #: 04-0120F4Cty: SF/ALA Rte: 80 PM: 13.2/13.9File #: 99.28**WELDING INSPECTION REPORT****Resident Engineer:**Siegenthaler, Peter**Address:** 333 Burma Road**City:** Oakland, CA 94607**Report No:** WIR-017263**Date Inspected:** 09-Oct-2010**Project Name:** SAS Superstructure**OSM Arrival Time:** 700**Prime Contractor:** American Bridge/Fluor Enterprises, a JV**OSM Departure Time:** 1900**Contractor:** Zhenhua Port Machinery Company, Ltd (ZPMC)**Location:** Shanghai, China**CWI Name:** Li Yang and Zhu Zhong Hai**CWI Present:** Yes No**Inspected CWI report:** Yes No N/A**Rod Oven in Use:** Yes No N/A**Electrode to specification:** Yes No N/A**Weld Procedures Followed:** Yes No N/A**Qualified Welders:** Yes No N/A**Verified Joint Fit-up:** Yes No N/A**Approved Drawings:** Yes No N/A**Approved WPS:** Yes No N/A**Delayed / Cancelled:** Yes No N/A**Bridge No:** 34-0006**Component:** OBG Trial Assembly**Summary of Items Observed:**

Orthotropic Box Girder (OBG) at Trial Assembly Areas

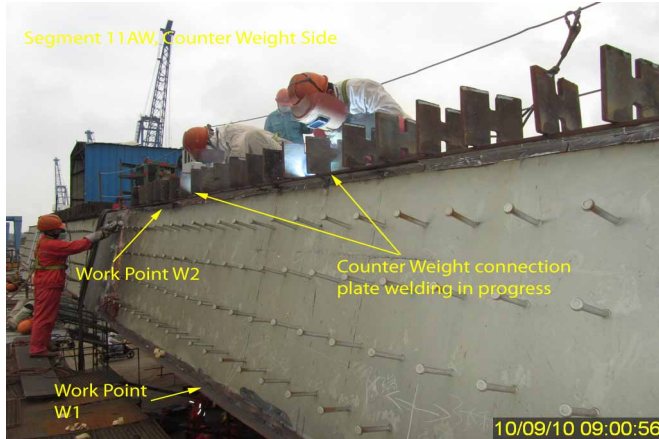
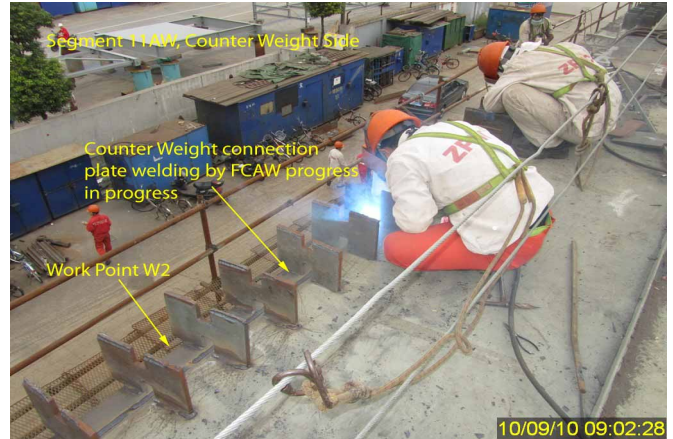
Please reference the pictures attached for more comprehensive details.
